Inspection Report Minerals Regulatory Program Report Date: September 2, 2004

Mine Name: Black Butte

Permit number: S/015/080

S/015/080, Black Butte Mine, GoldTerra

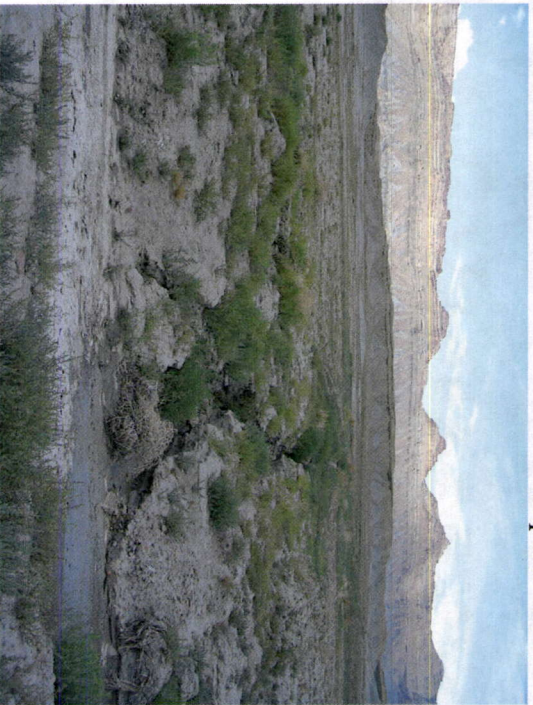
The road has deteriorated since the last inspection in March 2003. It does not appear to have been used in the interim. The road crosses several small washes (Photo 2) and two larger ones. I was able to drive across the first larger wash (in four wheel drive), but I could not get across the second one (Photo 1).

Photo 1. The second drainage crossing. I did not attempt to cross this drainage in my truck.

The Notice of Intention says culverts will be installed in these two larger drainages but this has not been done. If the operator begins hauling material from the mine, the culverts should be installed.

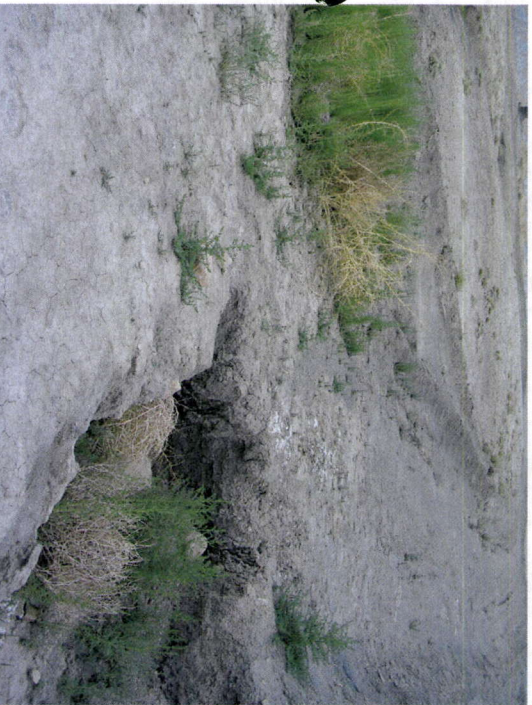
Photo 2. This is where the road crosses one of the minor drainages. I do not believe this road has been used recently.

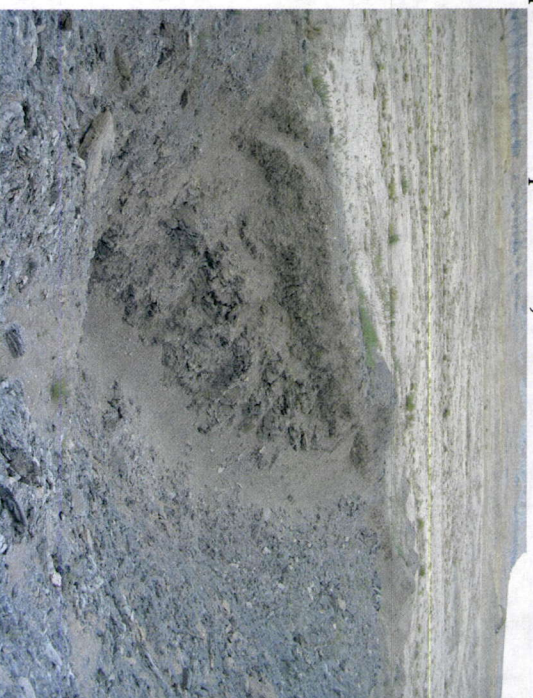
Not counting the road, the mine has disturbed about one acre. This disturbance consists of a pit about fifteen feet deep with a pile of excavated material next to it (Photos 3 and 4).

The pit walls are sloped such that a person or animal falling in to the pit could get out (Photo 3).

Photo 3. The mine pit. Note how the bottom is sloped on the far side; a person falling in to this pit could get out.

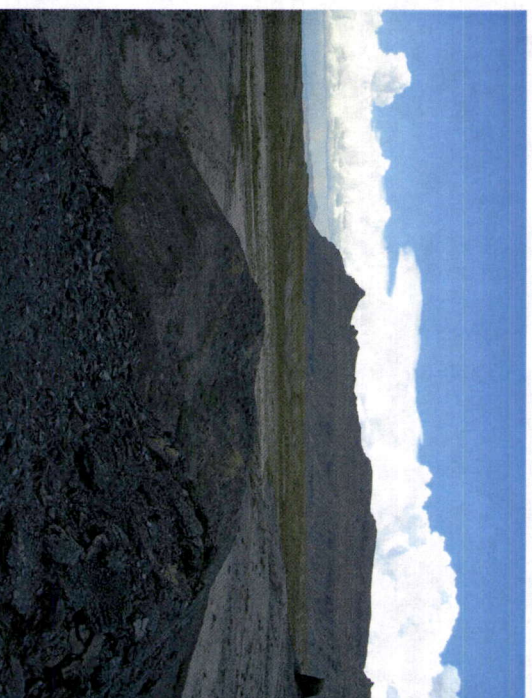
Photo 4. The pile of excavated material next to the pit.
